Manhole Inspection Summary

Manhole # S31UU1014MH

Insp Date: **3/19/07 12:10 PM**

Location Address: **114 HOMELAND AVE**

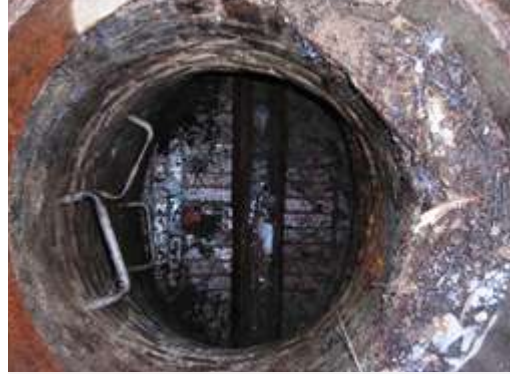
Top View

Bench debris.

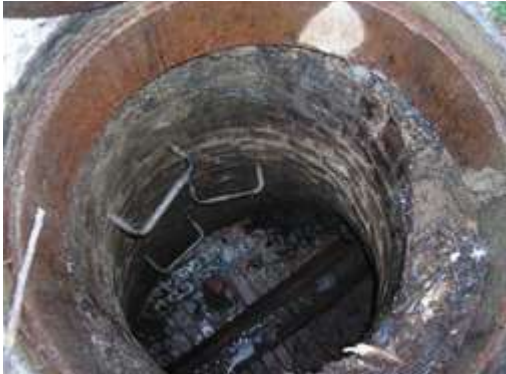
Defect

Frame leaks. Frame offset. Adjustment deterioration and infiltration. Corbel and Barrel infiltration.

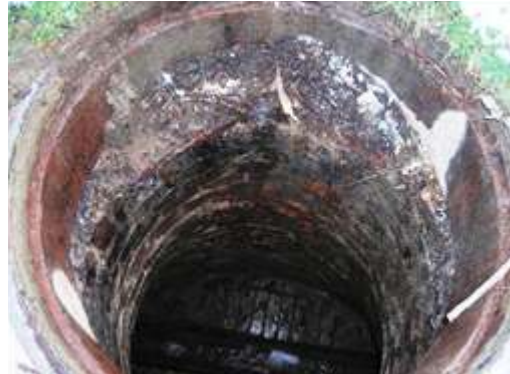
Defect

Frame leaks. Frame offset. Adjustment root intrusion and infiltration. Corbel and Barrel infiltration.

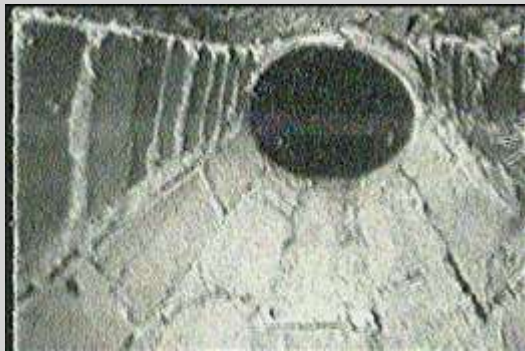
Pipe In @ 6 O'Clock

Channel deterioration.
